April 14, 2006  
Arc Flash Incident  
Building 1006A  
Brookhaven National Laboratory

Jim Tarpinian  
Director  
Environment, Safety, Health and Quality

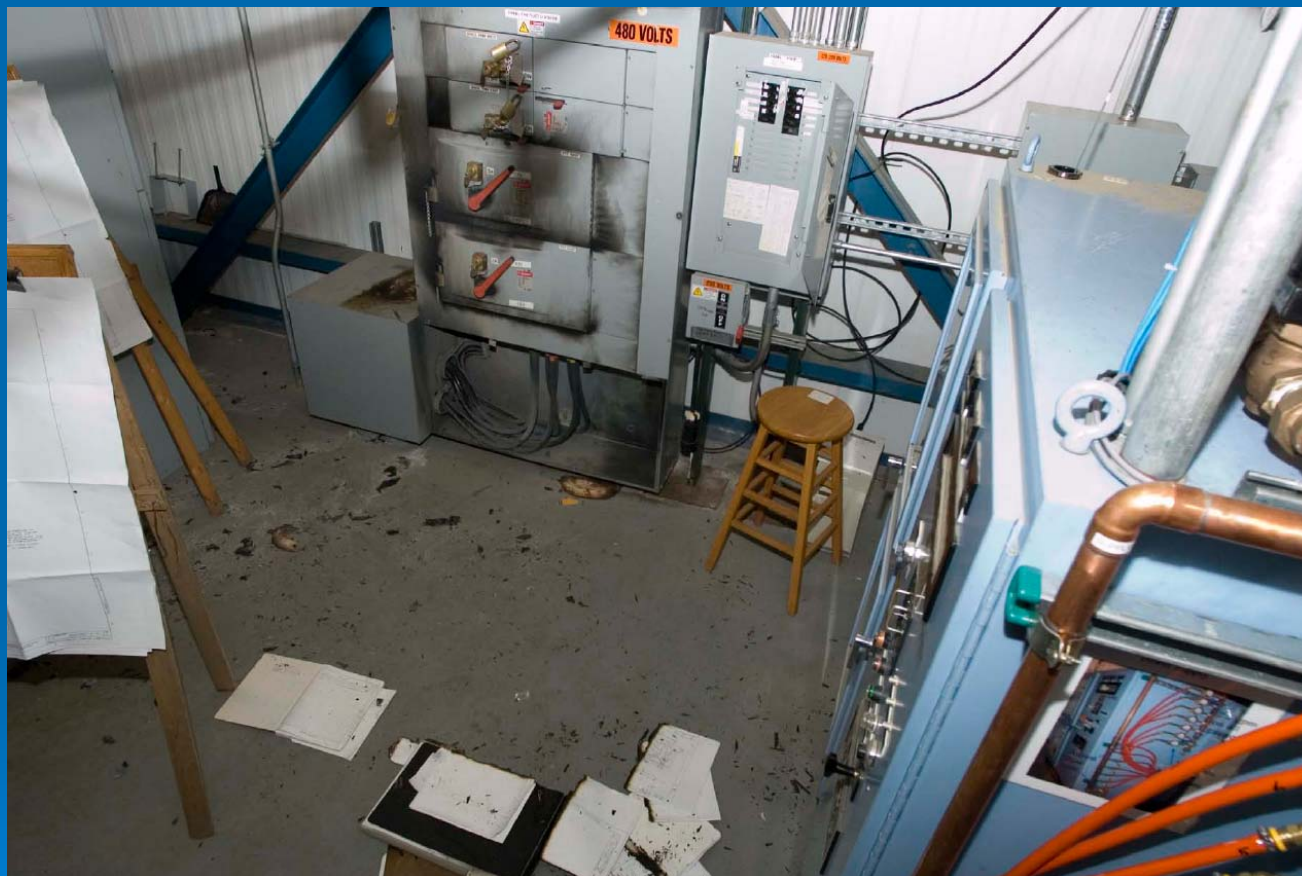
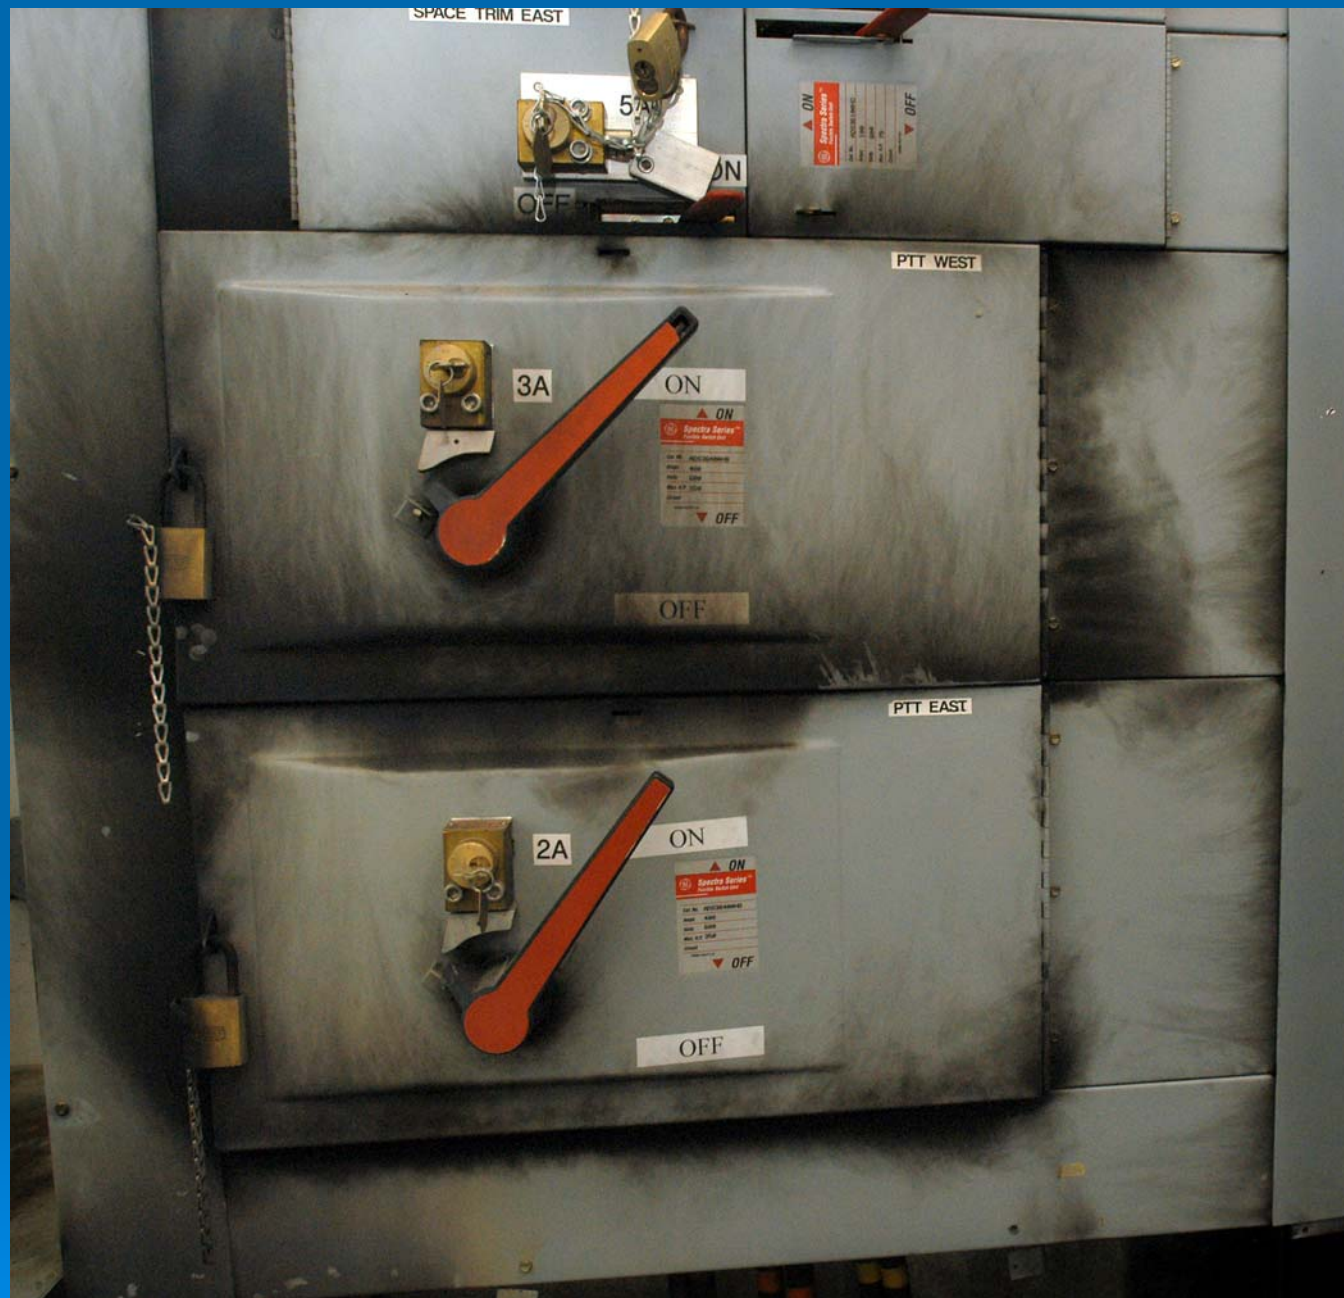
- April 14, 2006 at ~1020
- Building 1006A Mechanical Loft
- Engineer operates 480 V 400 amp disconnect switch
- Arc flash injuries:
  - 1<sup>st</sup> degree burns to head, face, chest, and hands
  - 1<sup>st</sup> and 2<sup>nd</sup> degree burns to forearms
- Switch panel destroyed

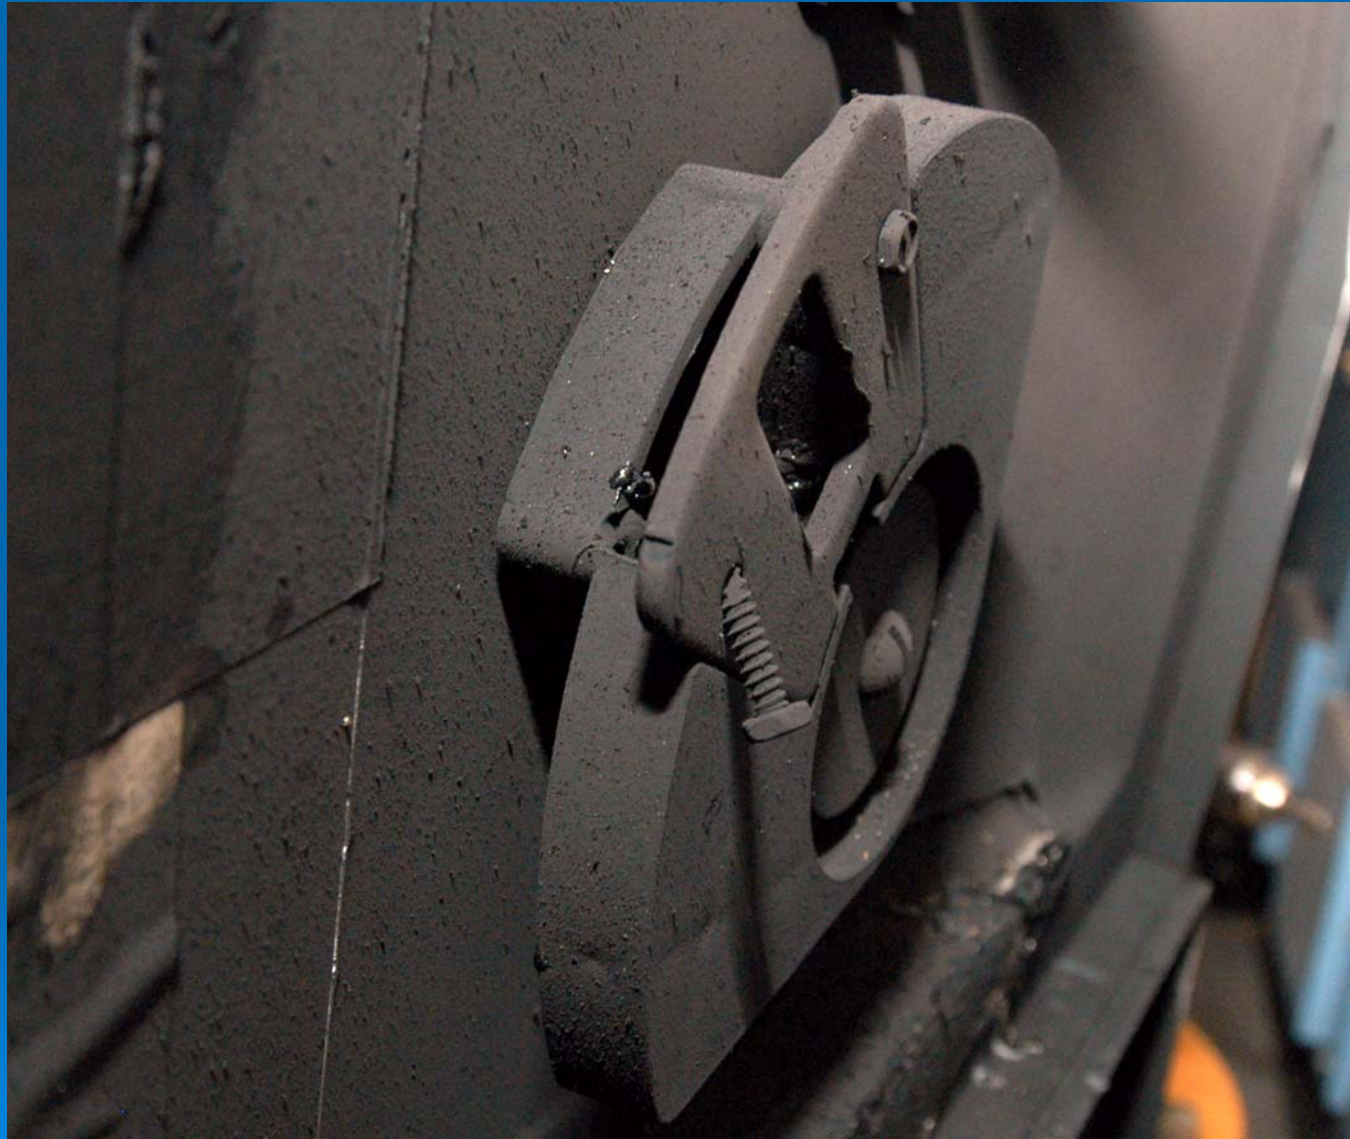
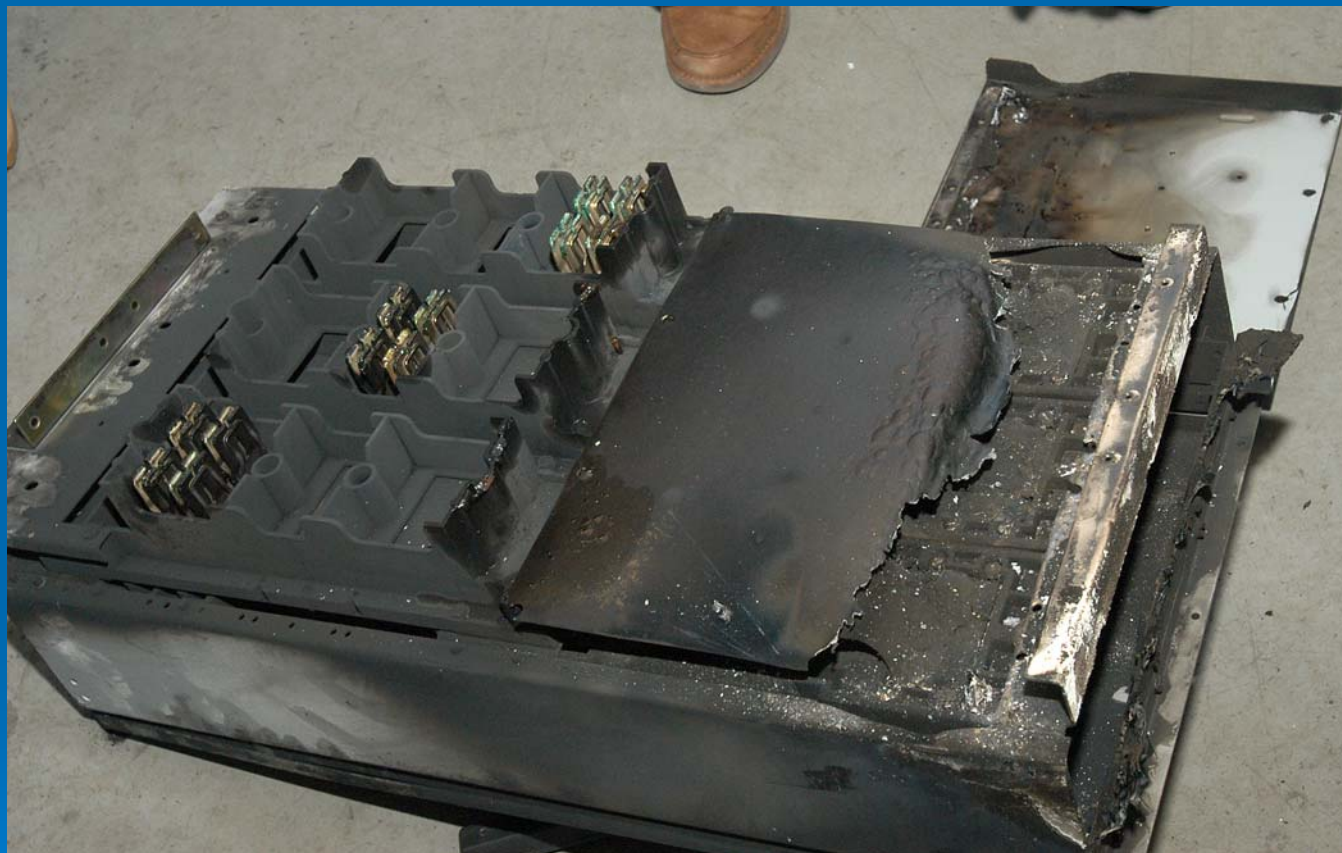
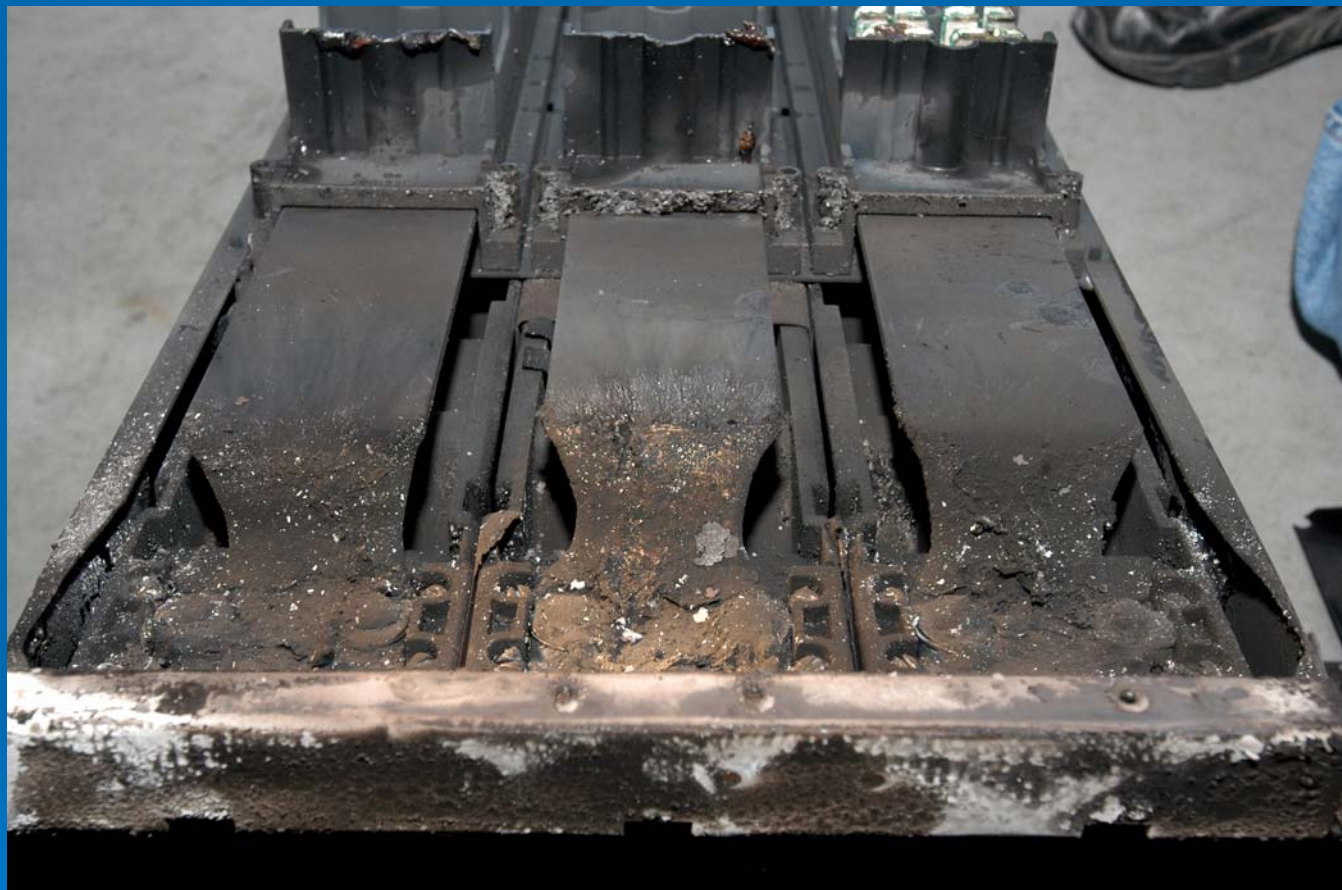
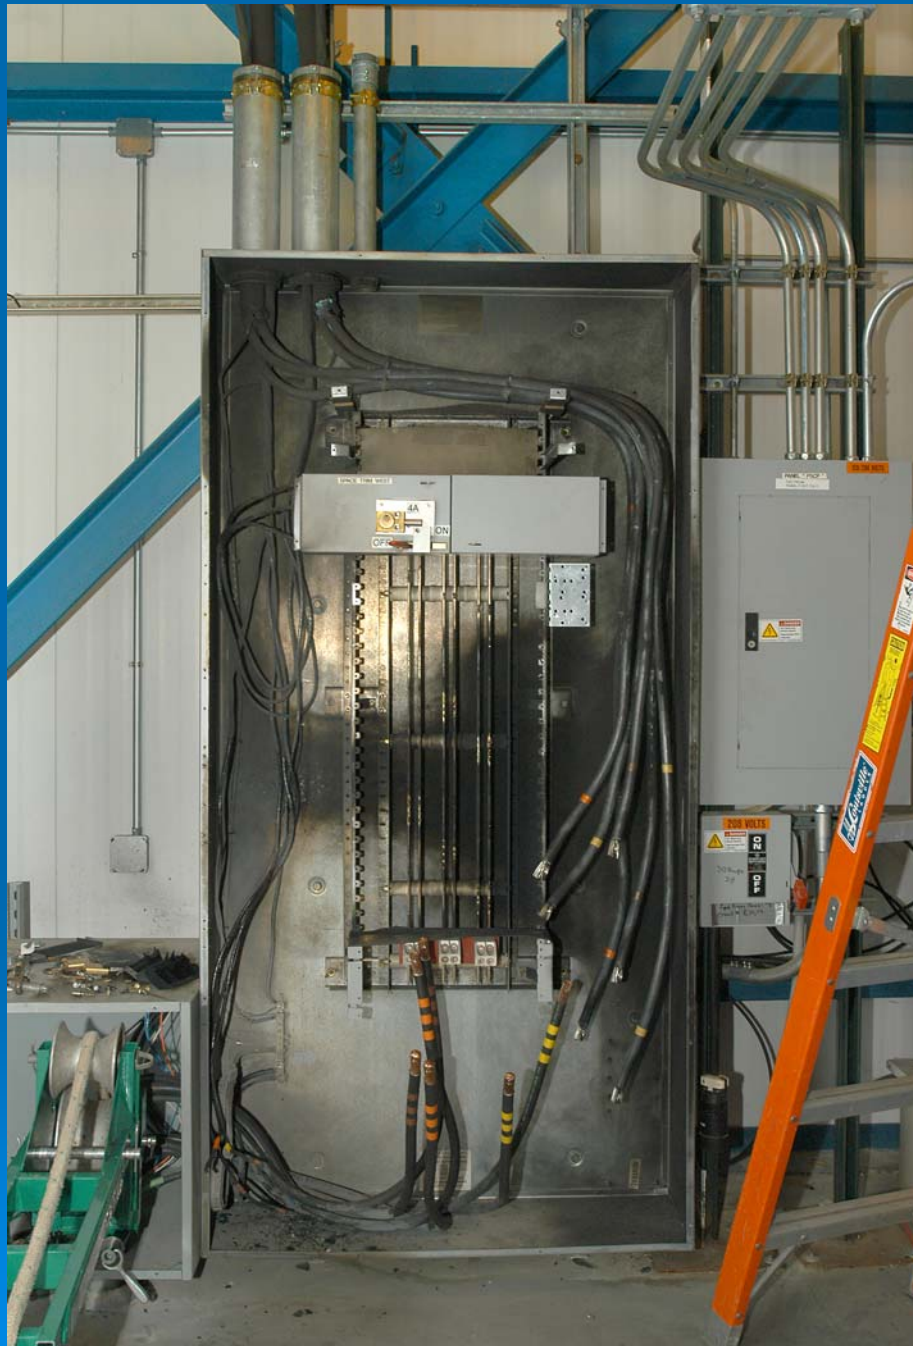
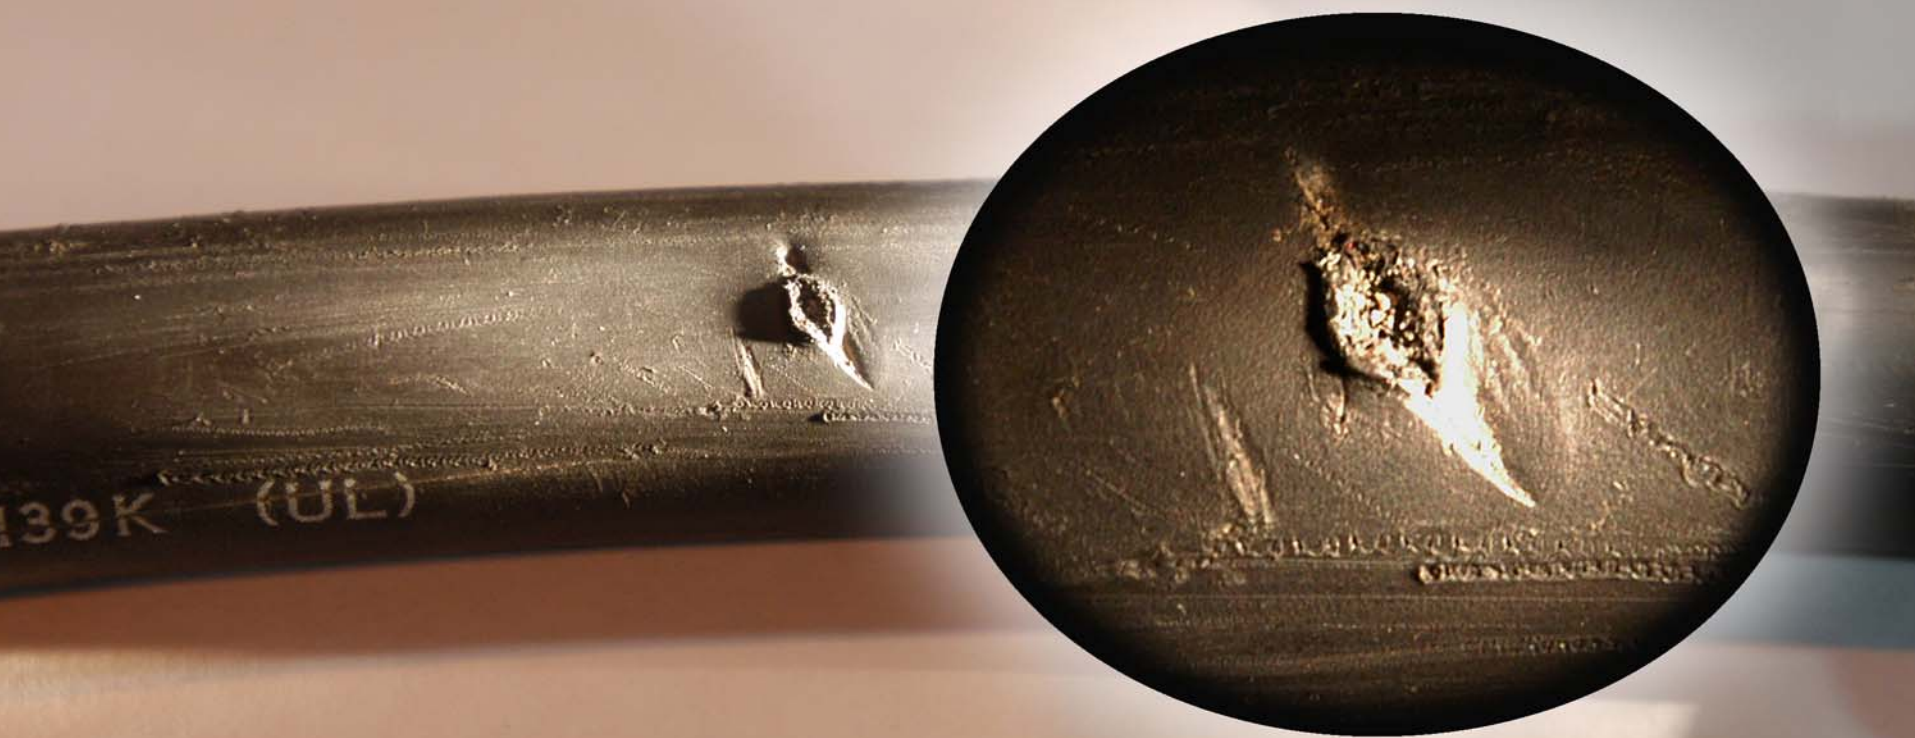
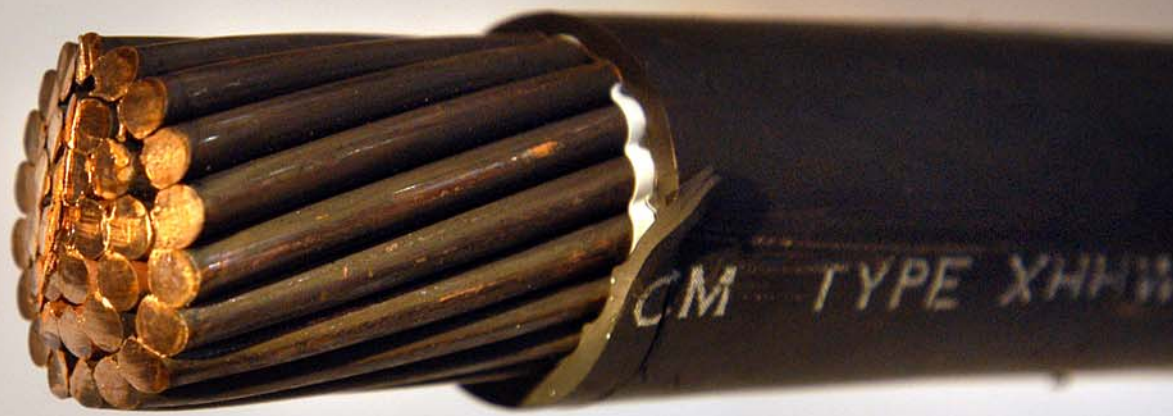
- High transient voltage
  - Arcing ground fault on ungrounded delta system (possible but unlikely)
- Foreign/loose object
  - Preliminary investigation of a similar switch indicates that the switch may have failed mechanically.
  - Area that show signs of cracking is plastic and is stressed when closing the switch.
  - If this part breaks free, it could allow a metal spring clip to enter the rear bus compartment where the arc flash occurred.
